ARMENIAN STUDIES  
ÉTUDES ARMÉNIENNES  
IN MEMORIAM HAÏG BERBÉRIAN

## BANAK: SIX PROJECTS FOR ITS RECONSTRUCTION

TIRAN MARUT'YAN

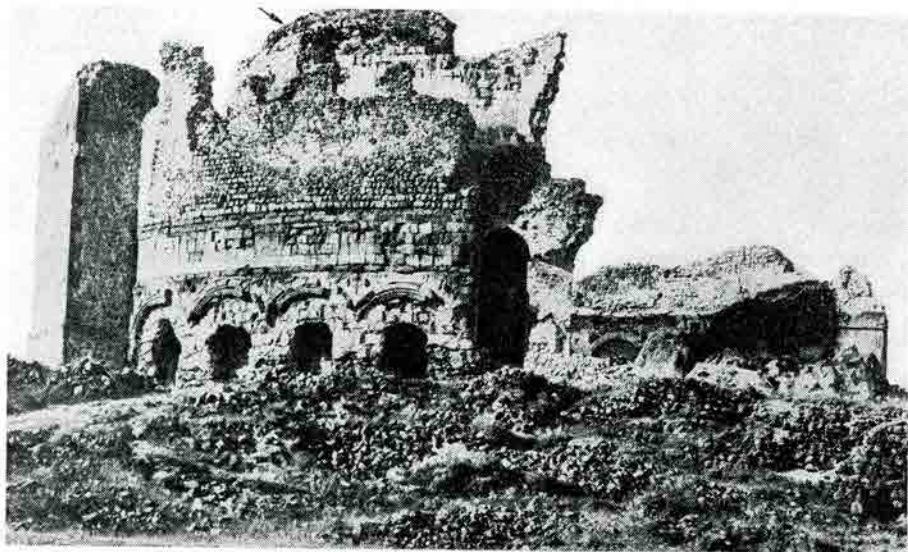
FIG. 1. Banak. Northeastern view of the ruins. Photograph (1902/1907).

tographs taken in 1902, 1907 (Fig. 1) (7) as well as in 1970 (Figs. 2,3) (8) leads us to the conviction that Kalgin's measurements were made with the utmost possible precision. Even a nearly completely demo-

There are quite a number of photographs in circulation of the church of Banak, two of which (Figs. 1 and 3) presented in this paper fully satisfy our requirements by demonstrating that Banak at the second level had also been circular and that the now ruined external circular wall had existed, requiring the existence of galleries in the form of passages in the four quarters as shown by Kalgin in his reconstruction of the second stage (Figs. 10-11).

The top part of the picture shows a wall having a rounded shape and located outside the triangular room in the northeastern quarter. Just here on the top (Fig. 1, shown by an arrow) is the once existing crown of the passage-like gallery that had cast a shadow over the angular section created by the two walls below.

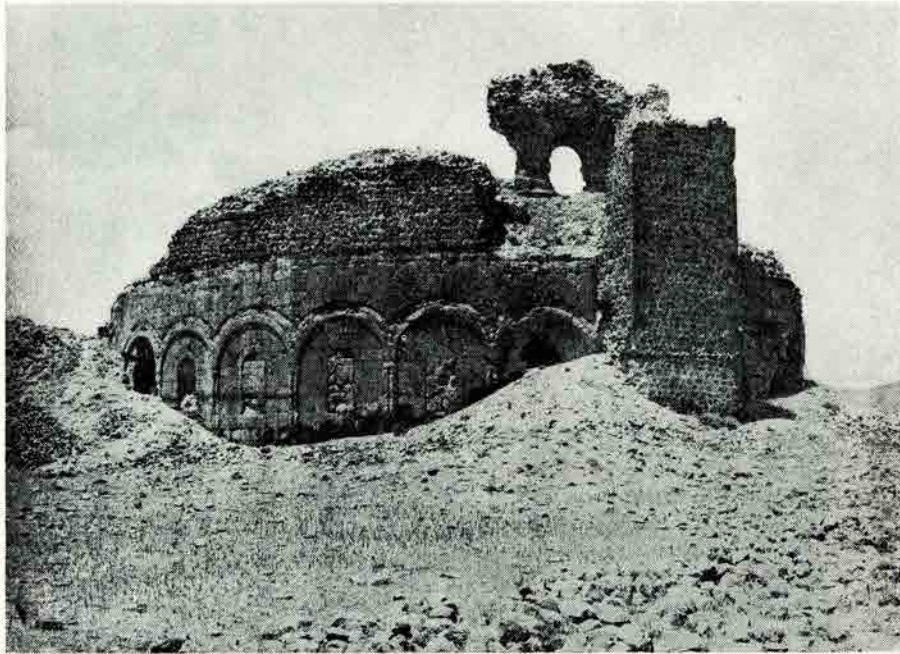
FIG. 2. Banak. Southeastern view of the ruins. Photograph (1970).

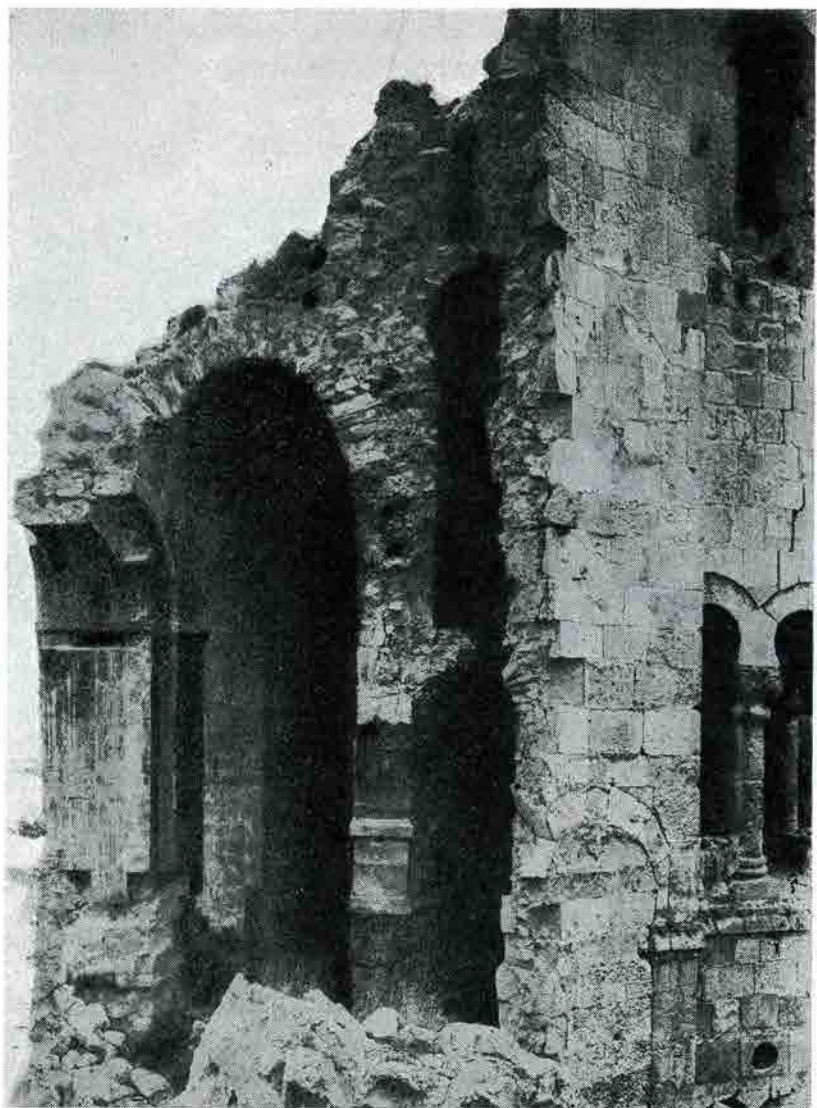
FIG. 3. Banak. Open ends of the gallery of the first and second storeys. Photograph (1970).

One of these photographs (Fig. 3) presents circular galleries of the first and second floors that were revealed by the destruction of the northern apse and the first drum wall. The second one is a famous picture (Fig. 1) presenting the general view of the northeastern part of the monument. This photograph was used in the above mentioned album by Mepisashvili and Tsintsadze on page 95 together with drawings of the reconstruction (p. 94). The right extremity of this wall at nearly the right angle reveals a projecting piece of masonry which is a side wall of the eastern window belonging to the northern apse. The left extremity of the same rounded wall shows a projecting side wall of the northern window belonging to the eastern apse.

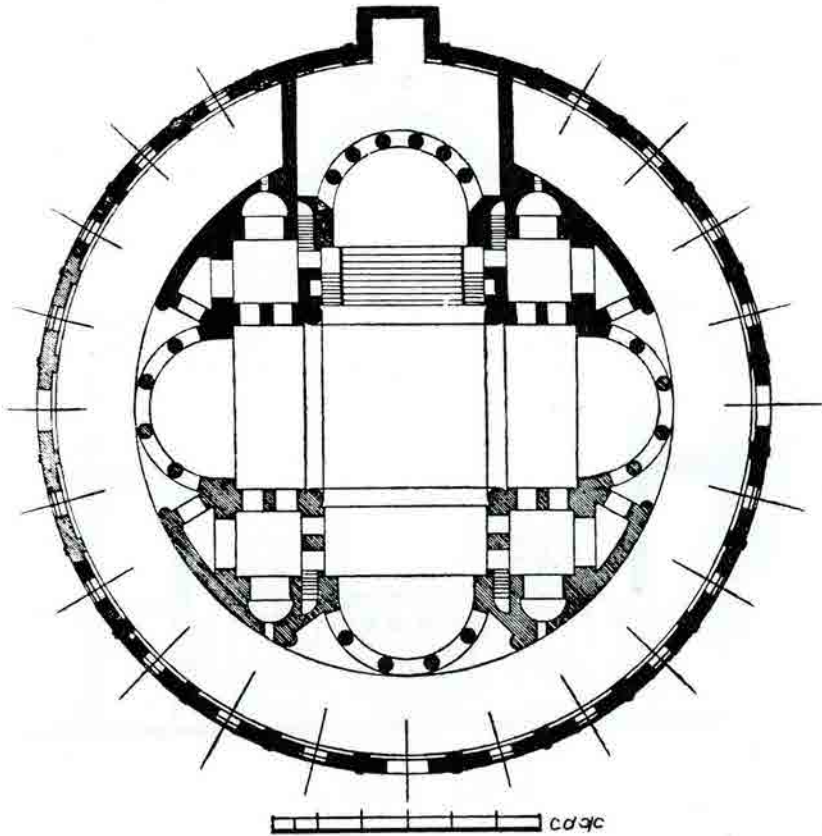
FIG. 6. Banak. Ground plan. Reconstruction by S. Kldiašvili (1902).

This reconstruction is represented by three plan drawings and one section (Figs. 6-7). According to it, the church was double-tiered, the first floor having a big drum and the second formed by a small dome-drum completed by a semi-spherical ceiling.

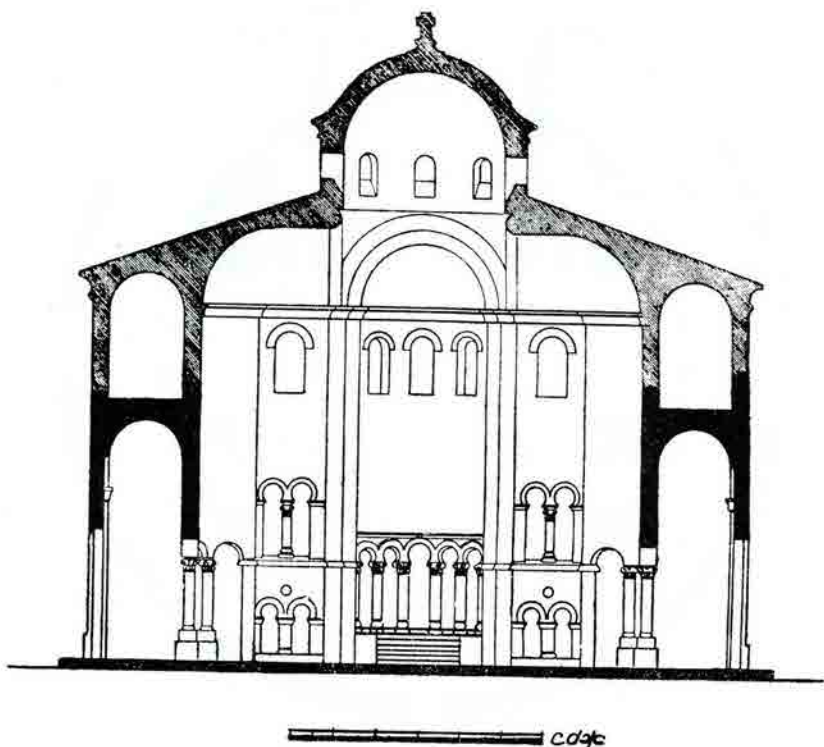
FIG. 7. Banak. Sectional elevation. Reconstruction by S. Kldiašvili.

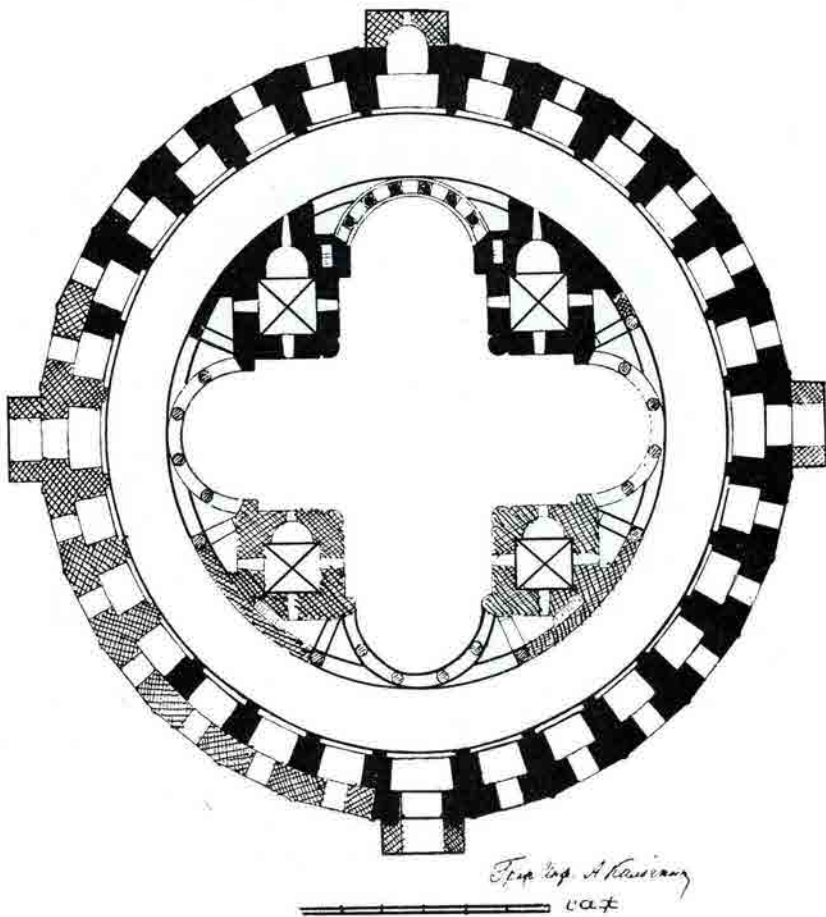
FIG. 8. Banak. Ground plan. Reconstruction by A. Kalgin (1907).

sions of the ruins. Kalgin's effort is represented by four plan drawings, one section, the west façade elevation, and some other partial drawings (Figs. 8-11).

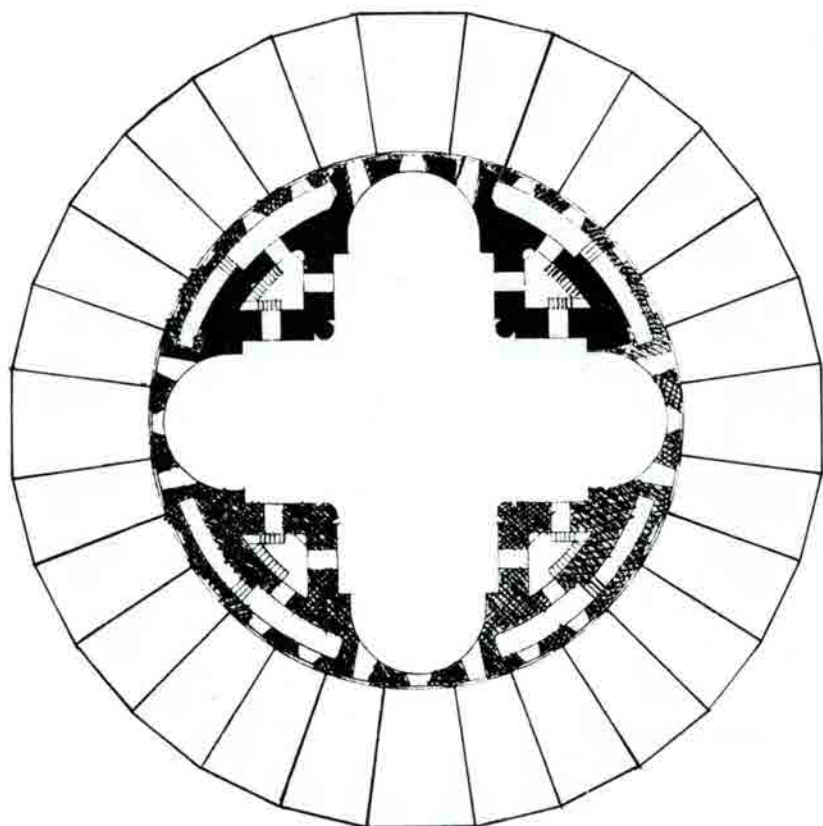
FIG. 9. Banak. Plan of the second storey. Reconstruction by A. Kalgin.

Perhaps at this moment it is worth recalling the first-hand, eyewitness evidence about the church at the end of the last century, contained in diaries of academician D. Bakradze (*supra* note 9), that says, «... on every storey there was a circular gallery». Furthermore, in connection with the diaries, it is interesting to present a diagrammatic drawing which basically resembles the plan of the church's second storey as shown by Kalgin in the passage-like gallery (in the four quarters) and in the external drum-like wall (Fig. 9).

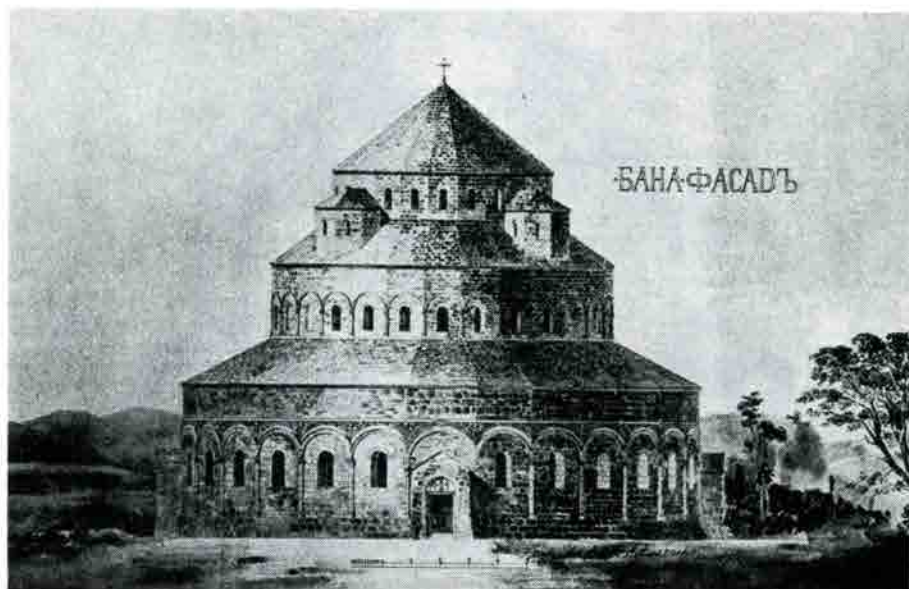
FIG. 11. Banak. Elevation of the western façade. Reconstruction by A. Kalgin.

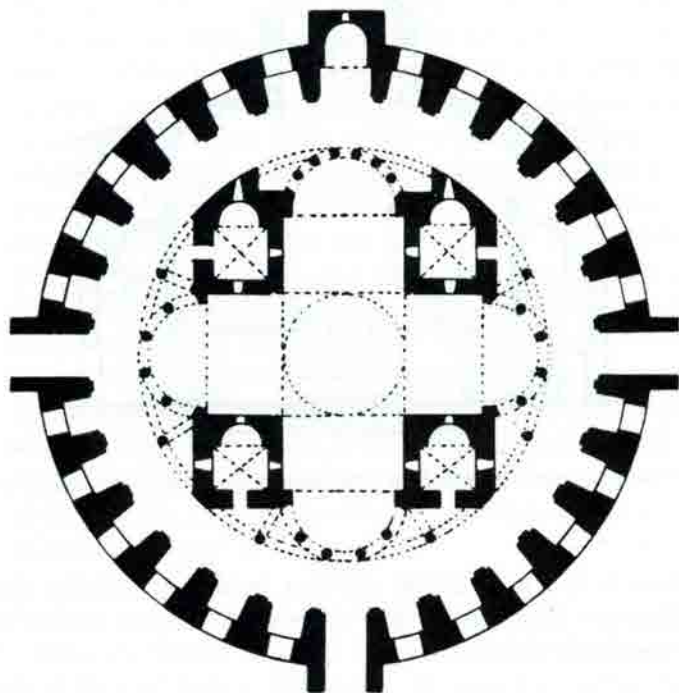
FIG. 12. Banak. Plan of the church after the handbook *Vseobščaja istorja arhitekturi* (*The General History of Architecture*).

The third successive reconstruction of Banak (Figs. 12-13) is to be considered the one presented in the drawings which have lately been published in specialized works and textbooks on the history of architecture and in encyclopaedias (10). That reconstruction has been

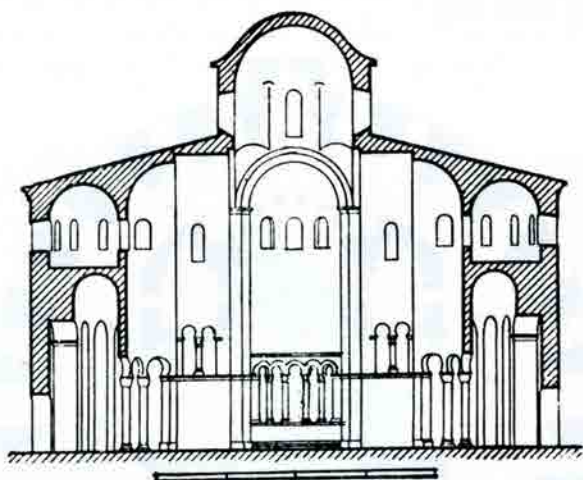
FIG. 13. Banak. Sectional elevation after the same. *Vseobščaja istorja arxitekturi.*

upright, small tower-like volumes, like those of Hrip'simē. In the third, as well as in the sixth reconstructions (Figs. 13, 18) the dome drum is presented with eight facets and four windows. The fifth reconstruction by Mnac'akanyan has twelve facets and as many windows (Fig. 16). In our reconstruction the dome drum has sixteen facets, so that of the evolved versions the first two give single windows on each of the facets, the third version shows windows on eight facets with the remaining eight facets carrying triangular niches each with a semi-conical top part.

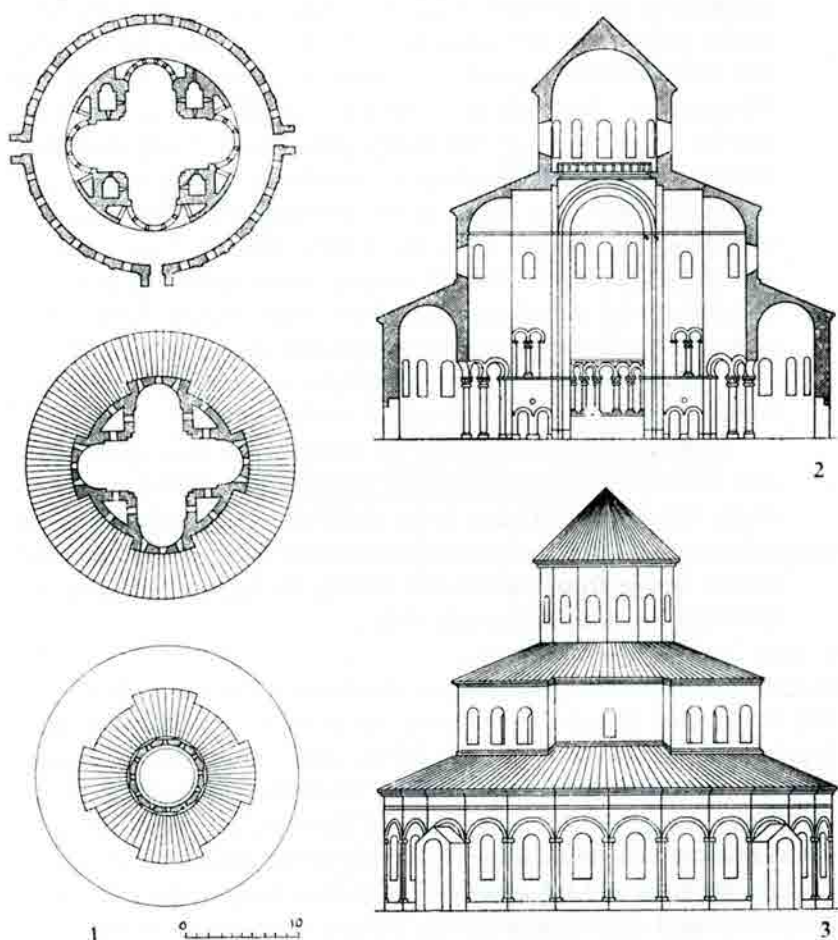
FIG. 14. Banak. Ground plan. Reconstruction by S. Mnac'akanyan (1971).  
 FIG. 15. Banak. Sectional elevation. Reconstruction by S. Mnac'akanyan.  
 FIG. 16. Banak. Front elevation in the diagonal direction. Reconstruction by S. Mnac'akanyan.

polygon) at the foundation and cross-shaped in the second stage (Figs. 14-16). The author arrived at this cross-shaped form by discarding as non-existent the four diagonal sections of the external circular wall, while the sections in the directions of the main axes with triple windows were retained in their positions, producing an unnatural two-meter projection from the inside circular wall.

S. Mnac'akanyan has presented a plan of the second floor of Banak without the external circular wall (Fig. 14). With it he rejects the once existing small circular crowned galleries in separate squares of the second floor. The coarsely built interior walls of these galleries are presented by him as the outside front walls of the church. Terminations of the triple-windowed apses are unjustly and unnaturally presented as projecting over the arch-shaped plan of the wall surface.

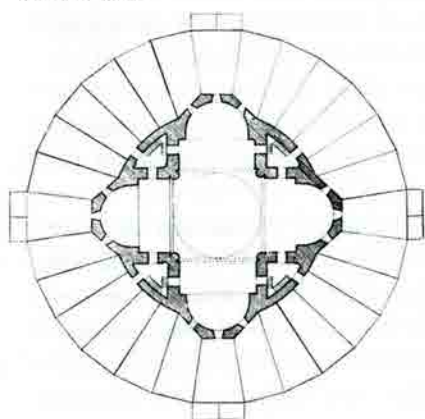
FIG. 17. Banak. Plan of the second storey. Reconstruction by R. Mepisashvili and V. Tsintsadze (1977).

In their own words, the authors attempted to represent the originally constructed church (Figs. 17-18). It is to be noted that the west façade of the first floor is pictured in the same way as that of Kalgin. Only in one fragment did they deviate from the situation existing in the ruins. Thus, an old photograph of the central facet on the east shows that the two columns on both sides of the entrance have double capitals, the right and left arches of the facet resting on the top capital and the central arch resting on the bottom capital and embracing a wider facet.

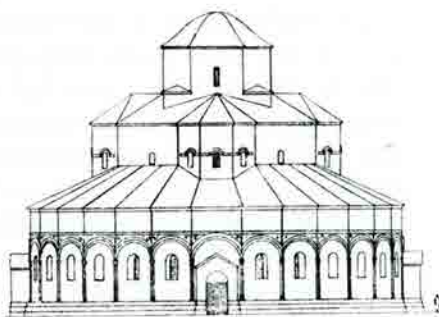
FIG. 18. Banak. Elevation of the western façade. Reconstruction by R. Mepisashvili and V. Tsintsadze.

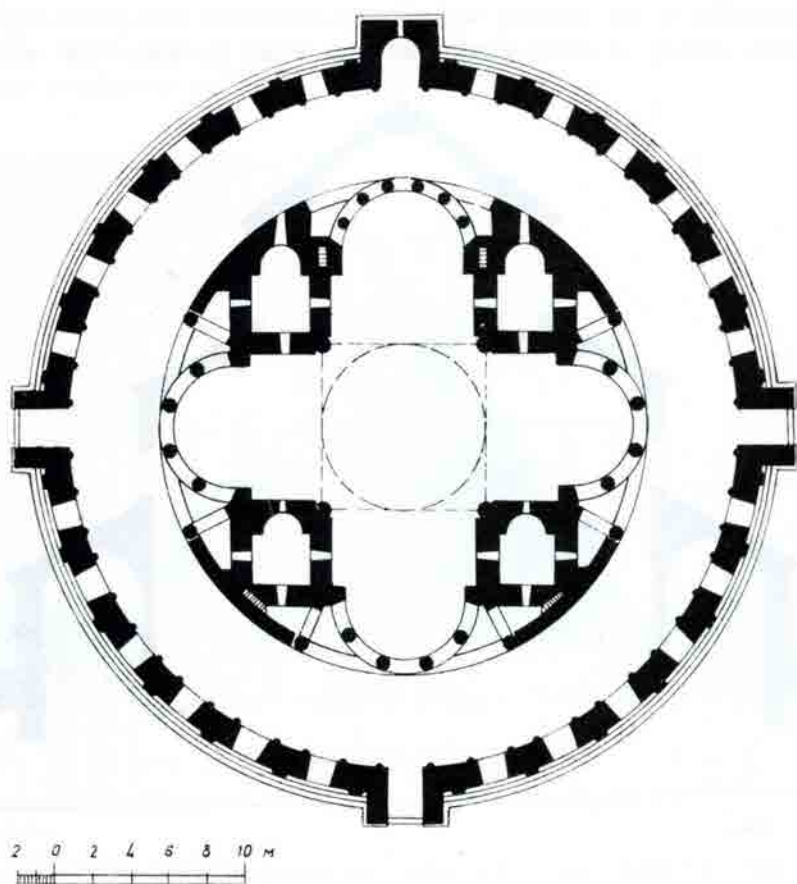
FIG. 19. Banak. Ground plan. Reconstruction by T. Marut'yan (1963).

This reconstruction (Fig. 19) represents what had existed of the original church, excluding the additions or modifications of subsequent centuries. These latter have already been presented in the earlier reconstructions by Kldiašvili and Kalgin.

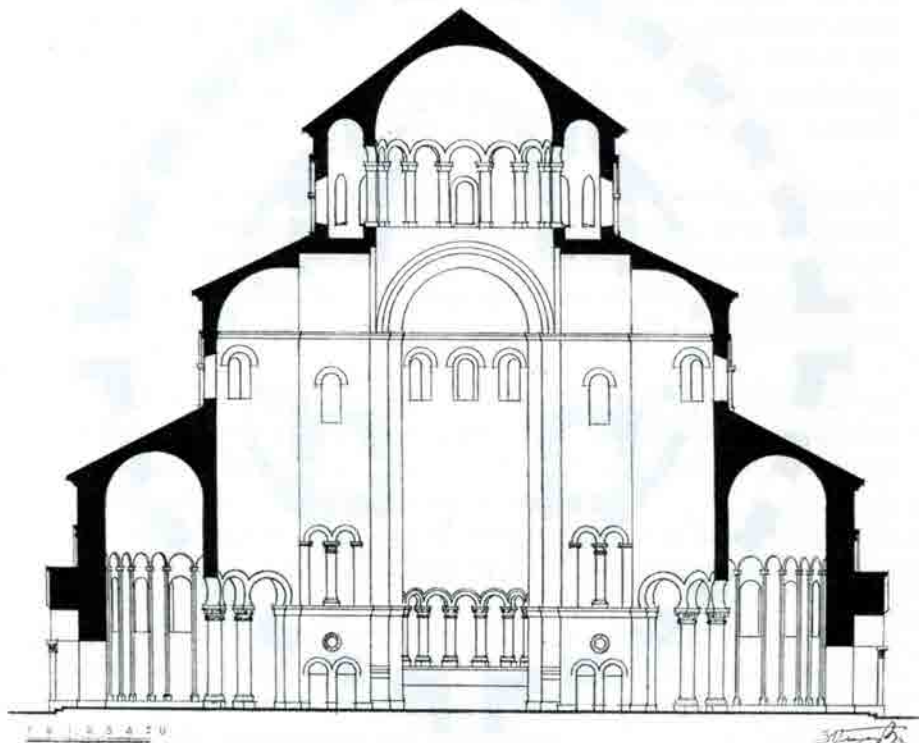
FIG. 20. Banak. Sectional elevation. Reconstruction by T. Marut'yan.

upright inside surface carrying traces of adjoining decorative arcades (19). A sectional drawing (Fig. 20) also presents, beside the ornamental

arcade in the original form and dimensions, the circular gallery and its crown with a five-meter span.

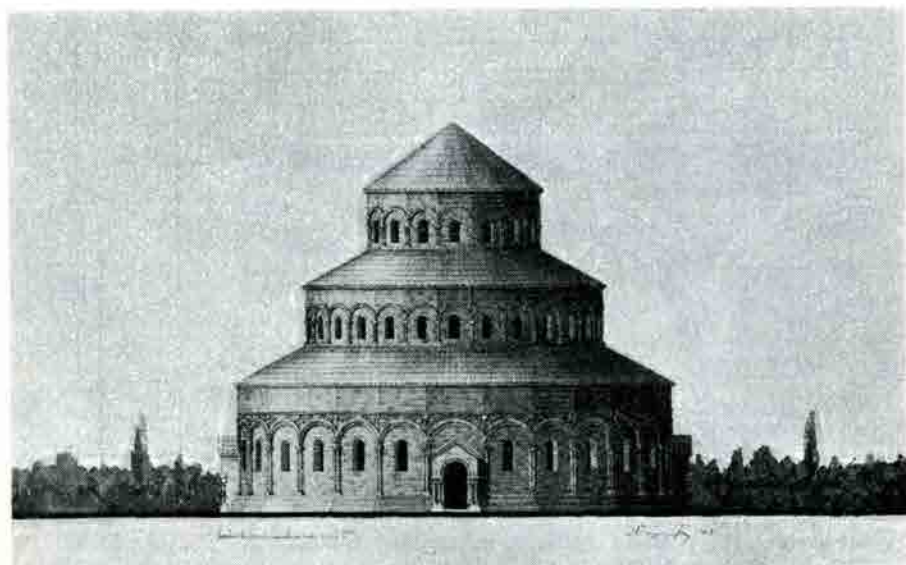
FIG. 21. Elevation of the western façade. Reconstruction by T. Marut'yan.

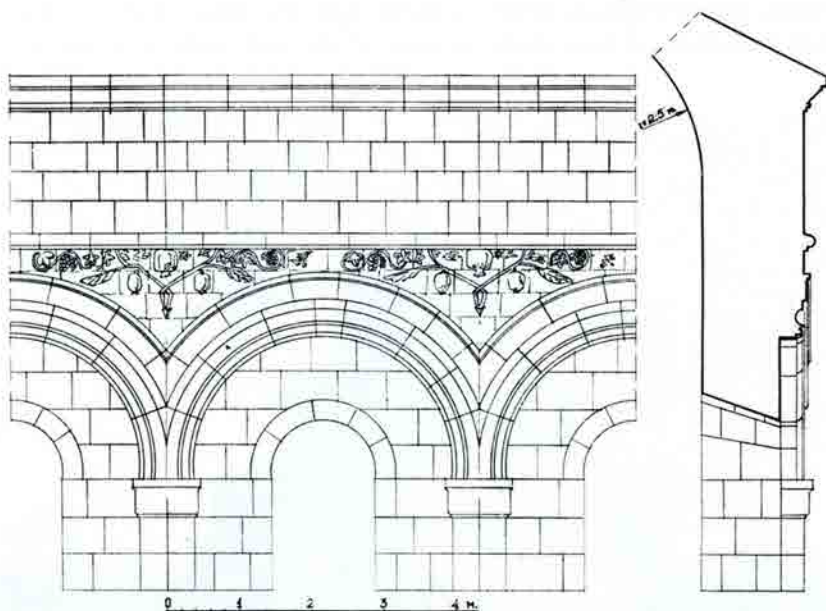
FIG. 22. Banak. A fragment of the decorative arcade on the outside wall of the first storey and ornamentation on the surface of the spandrel (seventh century).

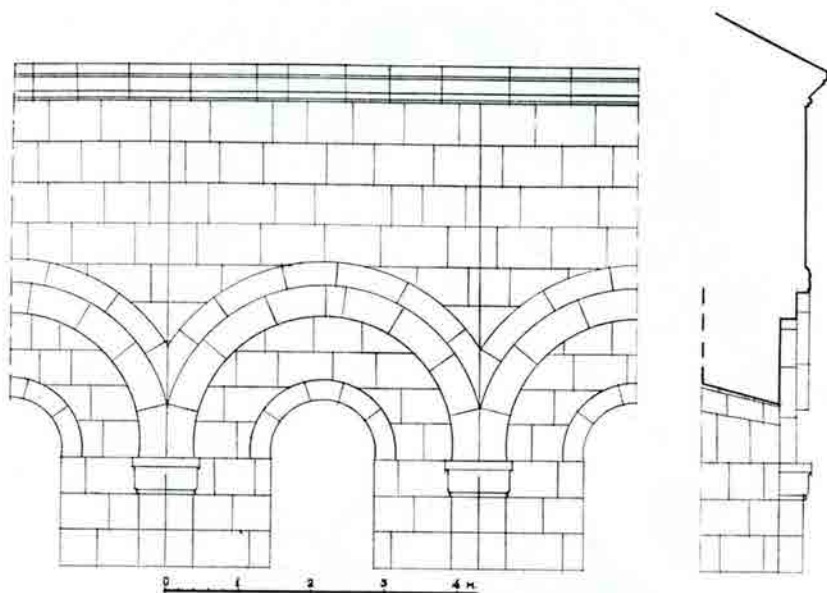
FIG. 23. Banak. A fragment of the decorative arcade on the outside wall of the first storey without the ornamentation in the spandrel (ninth-tenth century). Drawing by T. Marut'yan.

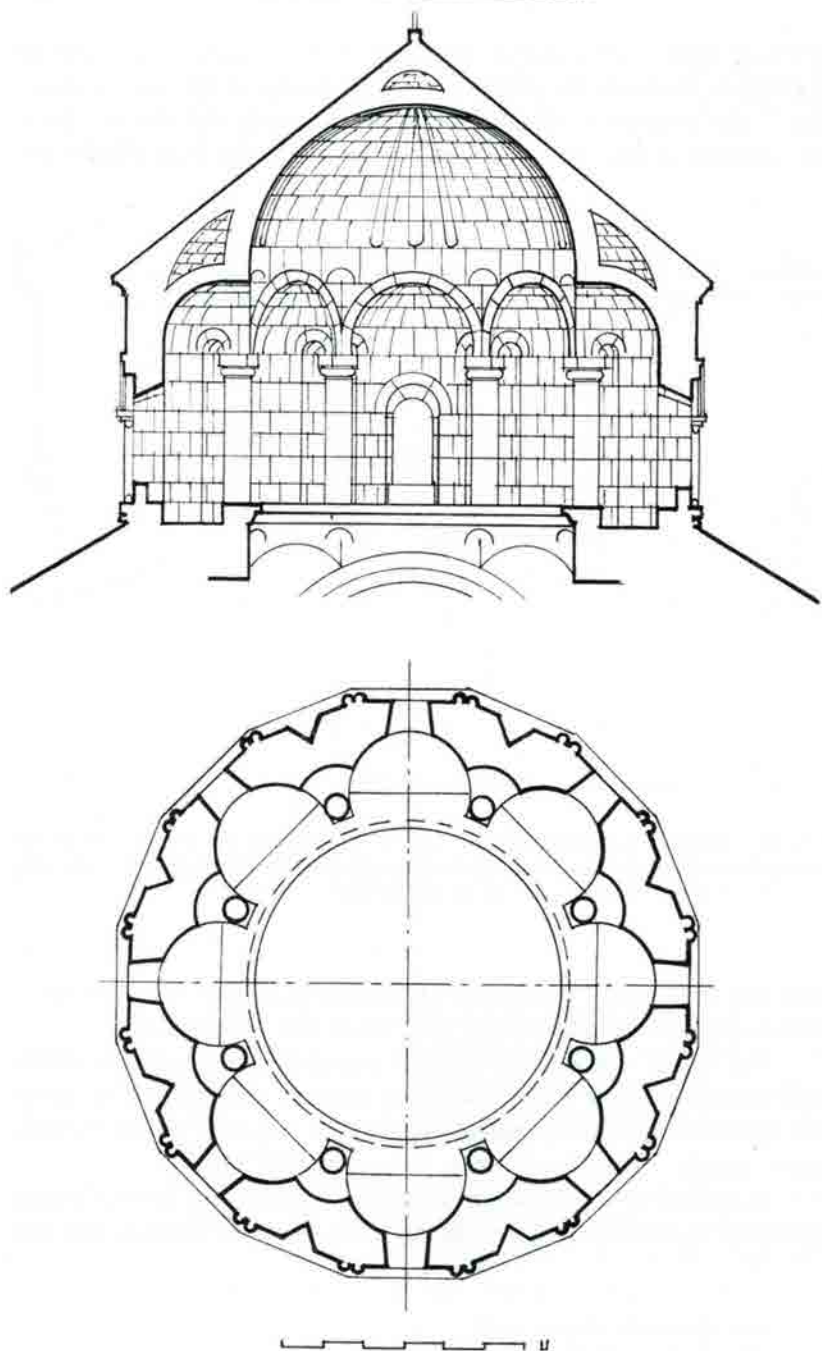
FIG. 24. Banak. A version of the dome section. Reconstruction by T. Marut'yan.

The third version (Fig. 24) of the dome drum has been developed on our part by using the example of the Elegendamor (Fig. 25) dome drum with its circular gallery. Inside the dome drum of Elegendamor the eight columns are standing, two for each arch with a uniform step on top of the dome-carrying arcade. The large niches bear the thrust from the dome-joiner system. The very thick drum wall was relieved by the eight niches. The spatially operating dome drum was capable of withstanding numerous earthquakes and preserving its existence up to our time.

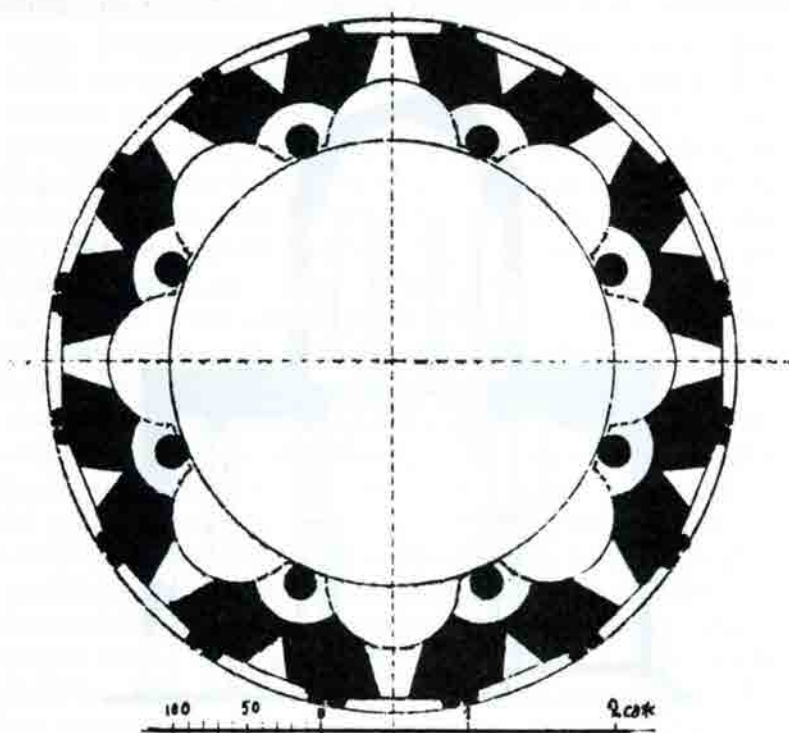
FIG. 25. Elegnamor (Changli-Kagizman). Plan of the dome section. Dimensioning by A. Kalgin (1907).

In the project by Kalgin (Figs. 25-26) the example of the Elegendamor dome received a different treatment. His circular gallery is developed in a more classical way with a rotunda. Introducing a passage

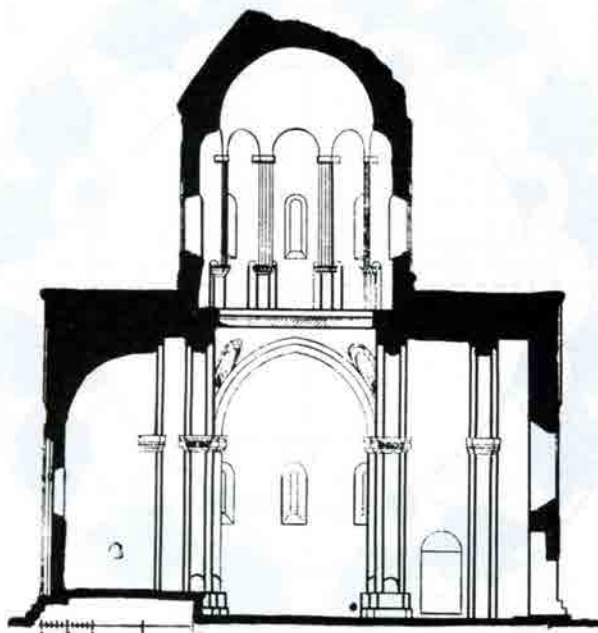
FIG. 26. Eleanamor. Sectional elevation. Dimensioning by A. Kalgin.
